Scour Evaluation and Countermeasure Design

by
Kirk Harvey
Bridge Hydraulic Engineer
Nebraska Department of Roads

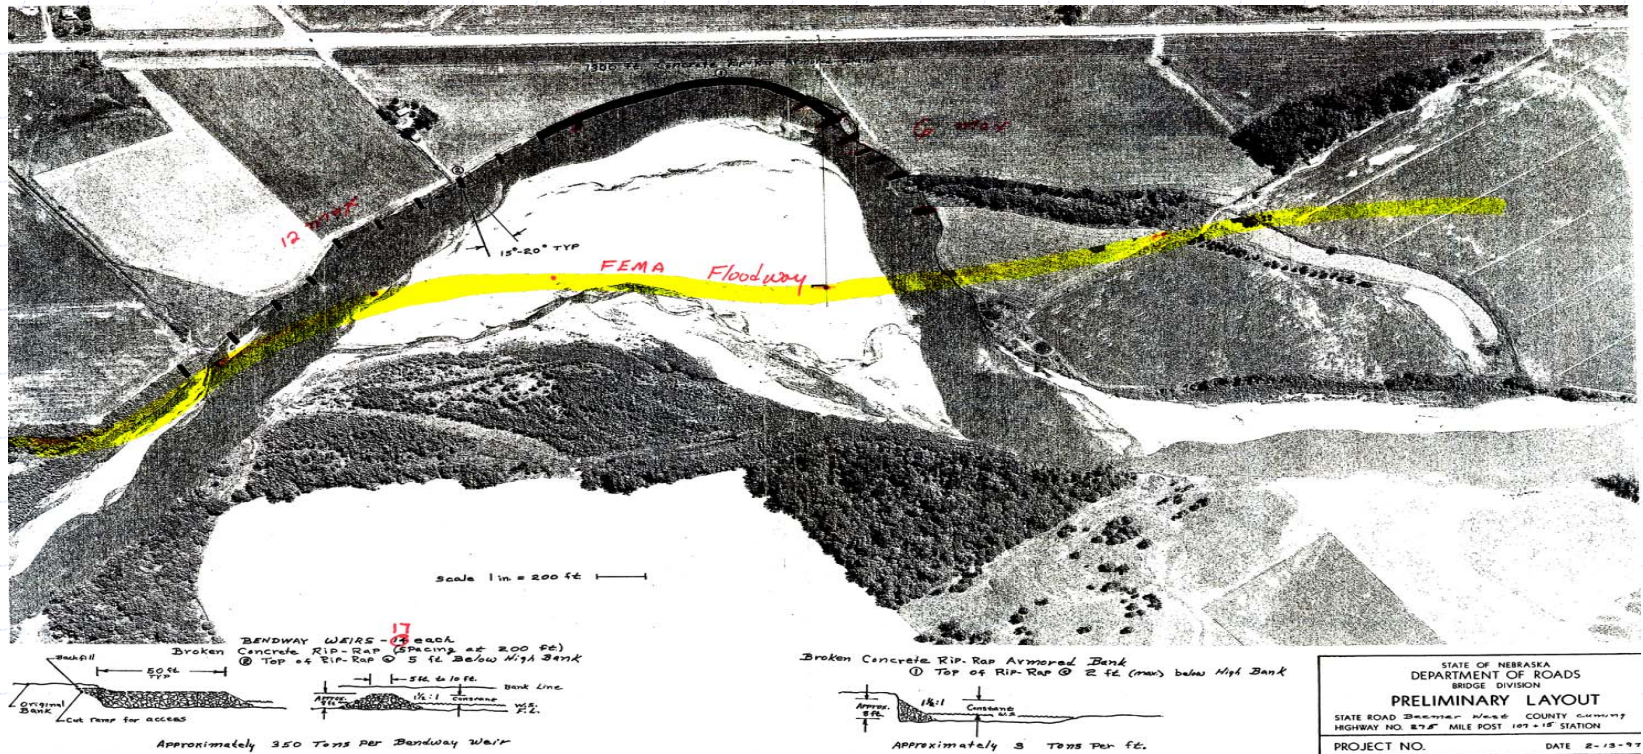
Example of active meandering

- ◆ Elkhorn River was cutting North through a corn field to Hwy. 275.

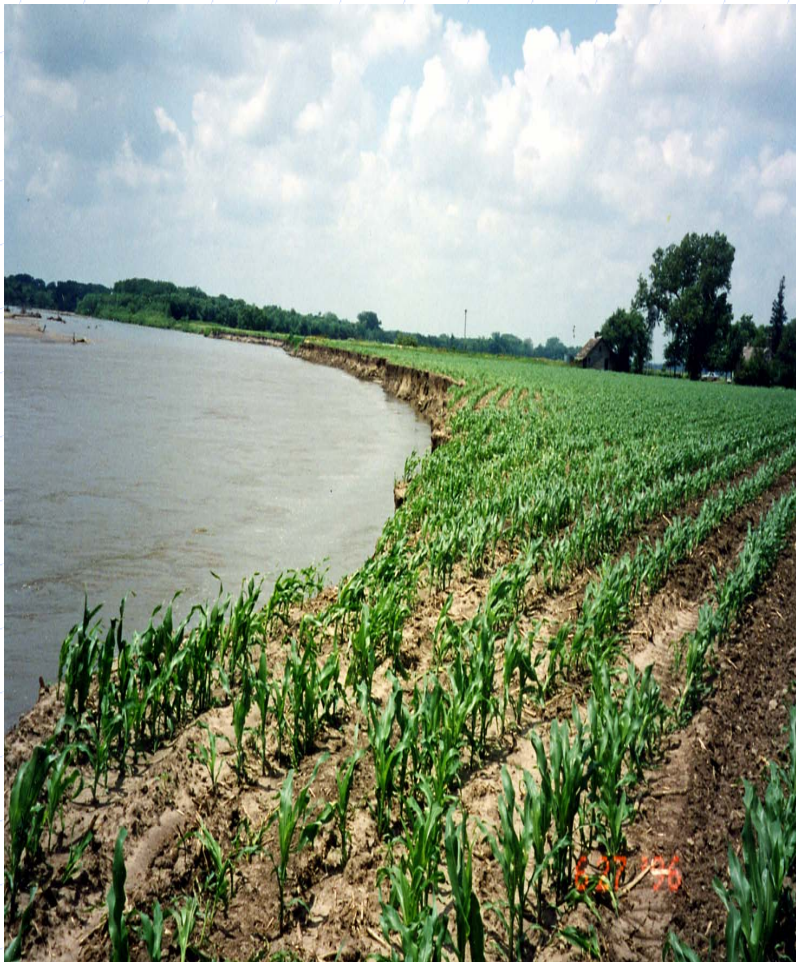
Impacts of active meandering

- ◆ Unstable banks
- ◆ Loss of farmland
- ◆ State highway in jeopardy
- ◆ Meandered an average of 50' per month

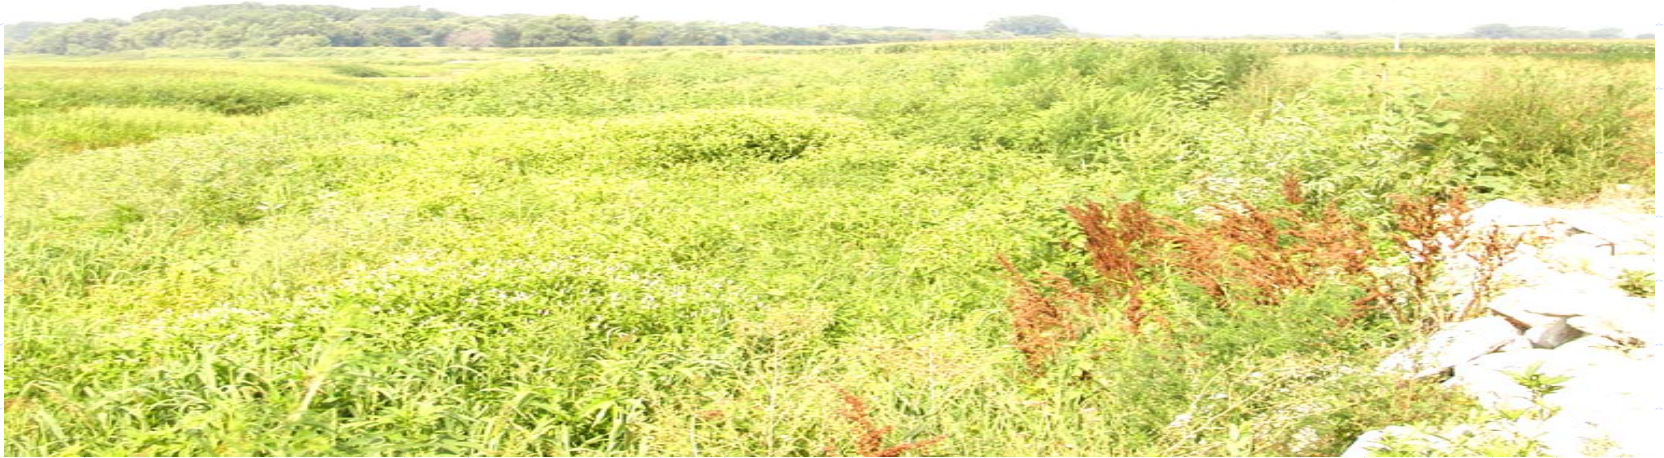
Results of countermeasure

◆ Vegetation re-established along the bank line

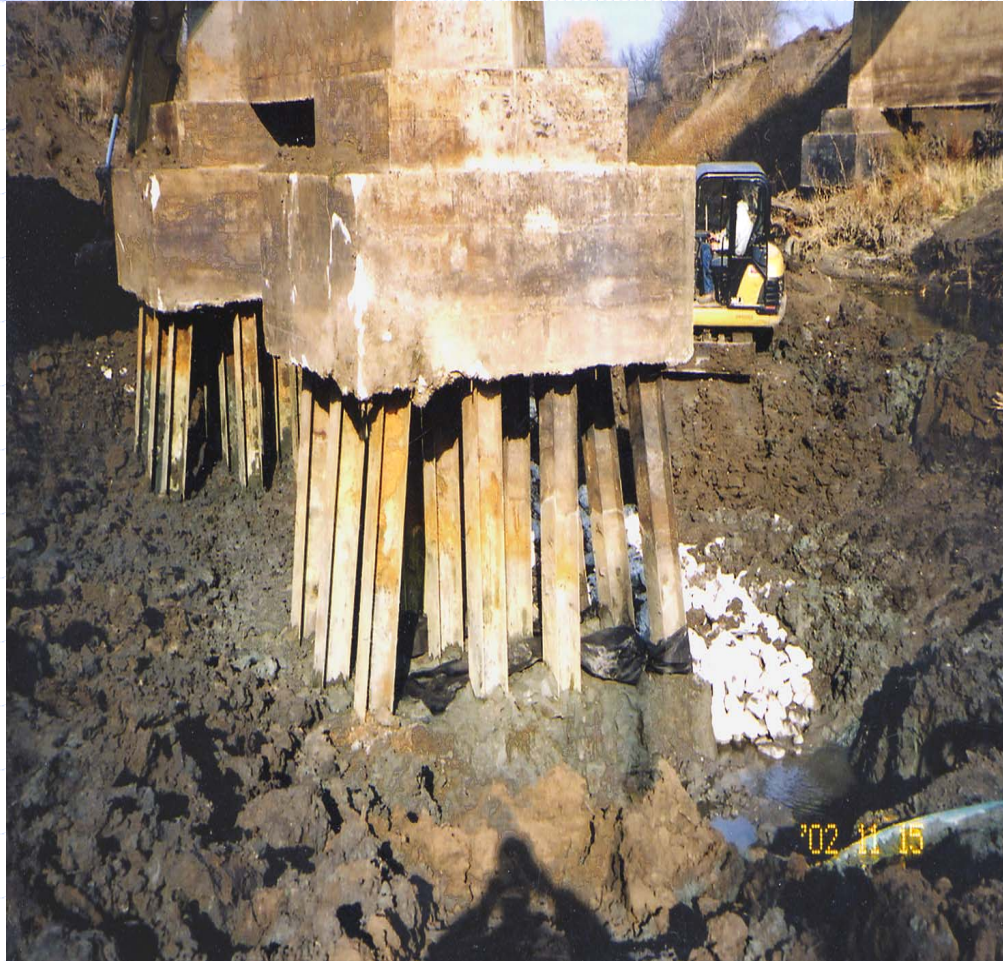
Example of degradation and local scour

- ◆ Little Nemaha River
- ◆ Channel degraded
- ◆ Pier piles were exposed
- ◆ Local pier scour
- ◆ Structure integrity

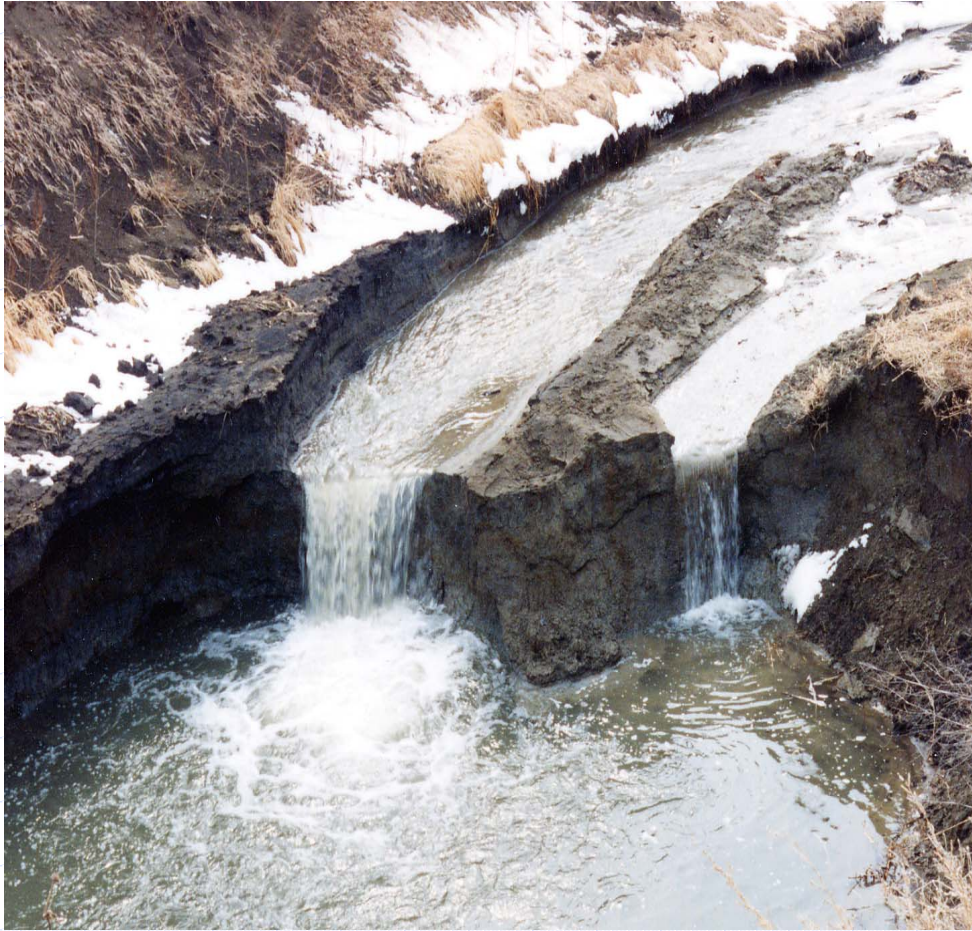
Example of a Headcut

- ◆ Logan Creek
- ◆ Downstream of bridge site
- ◆ 5' headcut
- ◆ Due to straightening of the channel downstream.

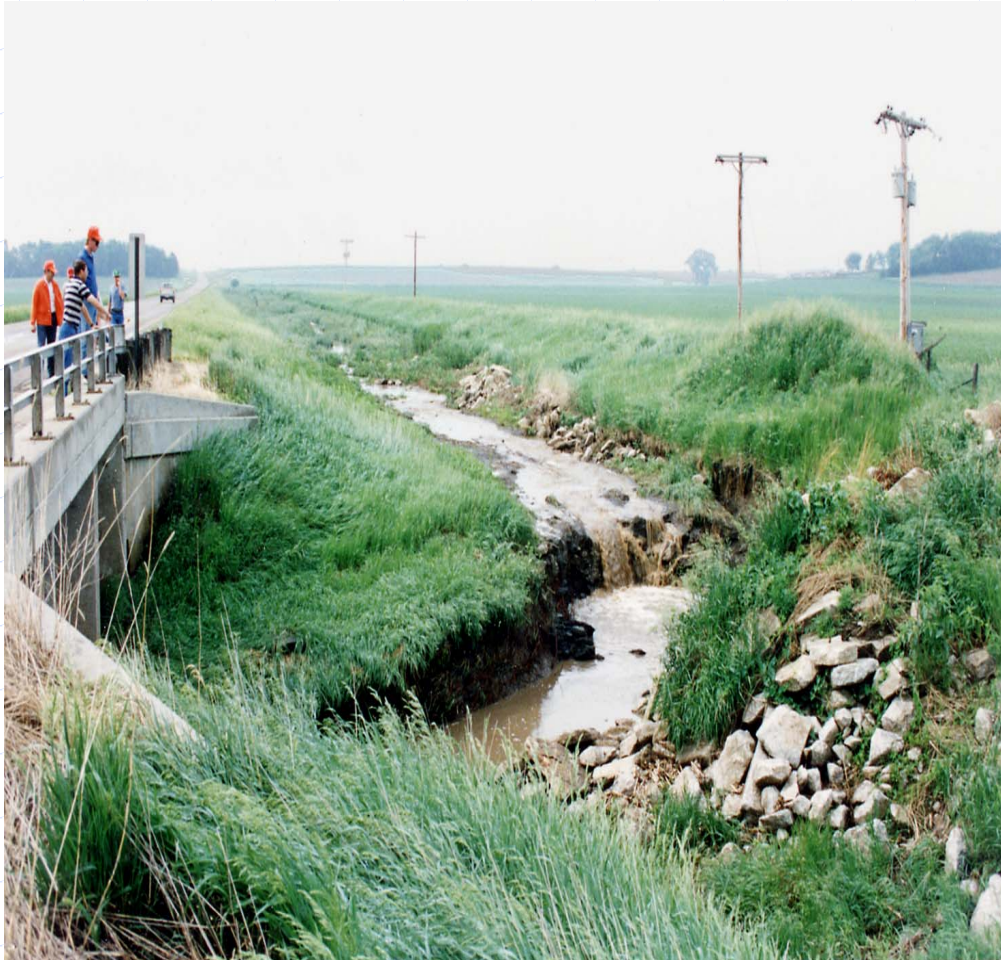
Example of a ditch headcut

- ◆ Degraded Plum Creek Tributary
- ◆ Bridge was stable
- ◆ Degradation advancing up the road ditch

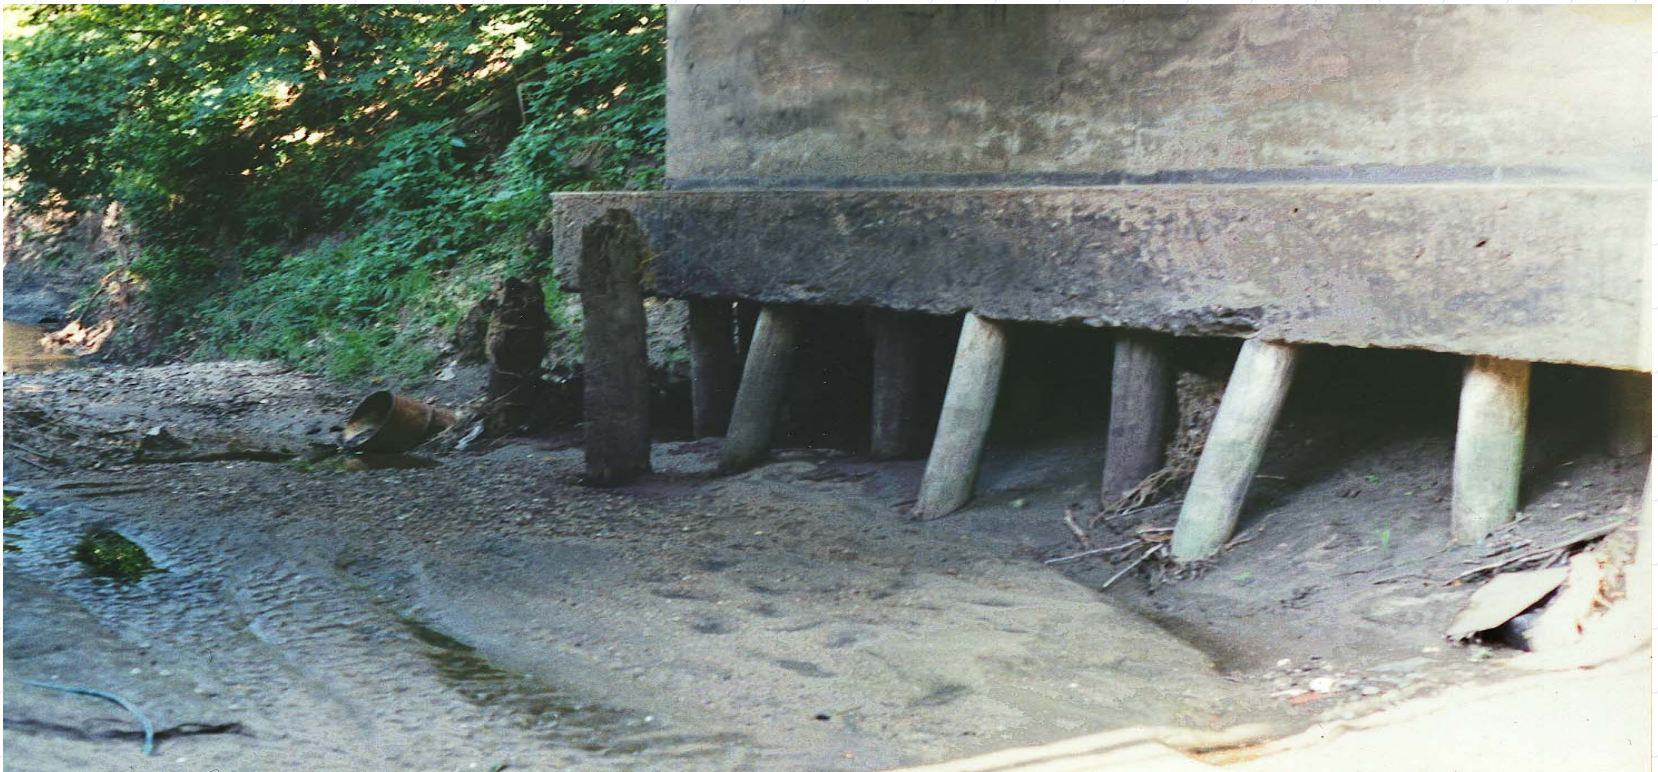
Example of abutment scour

- ◆ Concrete wall abutment
- ◆ Undermining abutment wall
- ◆ Approach failure imminent

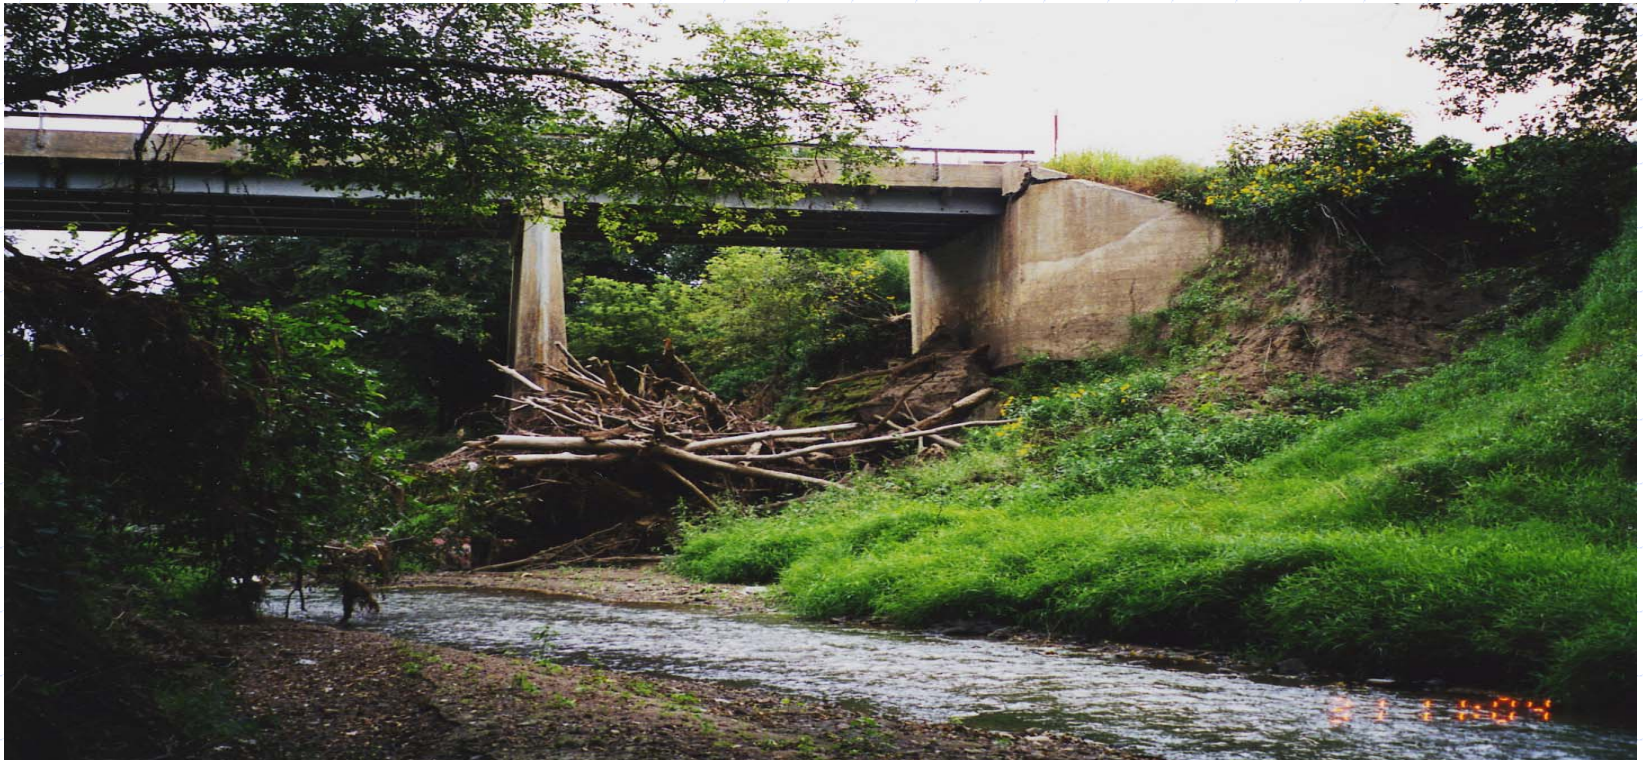
Example of abutment scour

- ◆ Undermining abutment
- ◆ Exposed piling

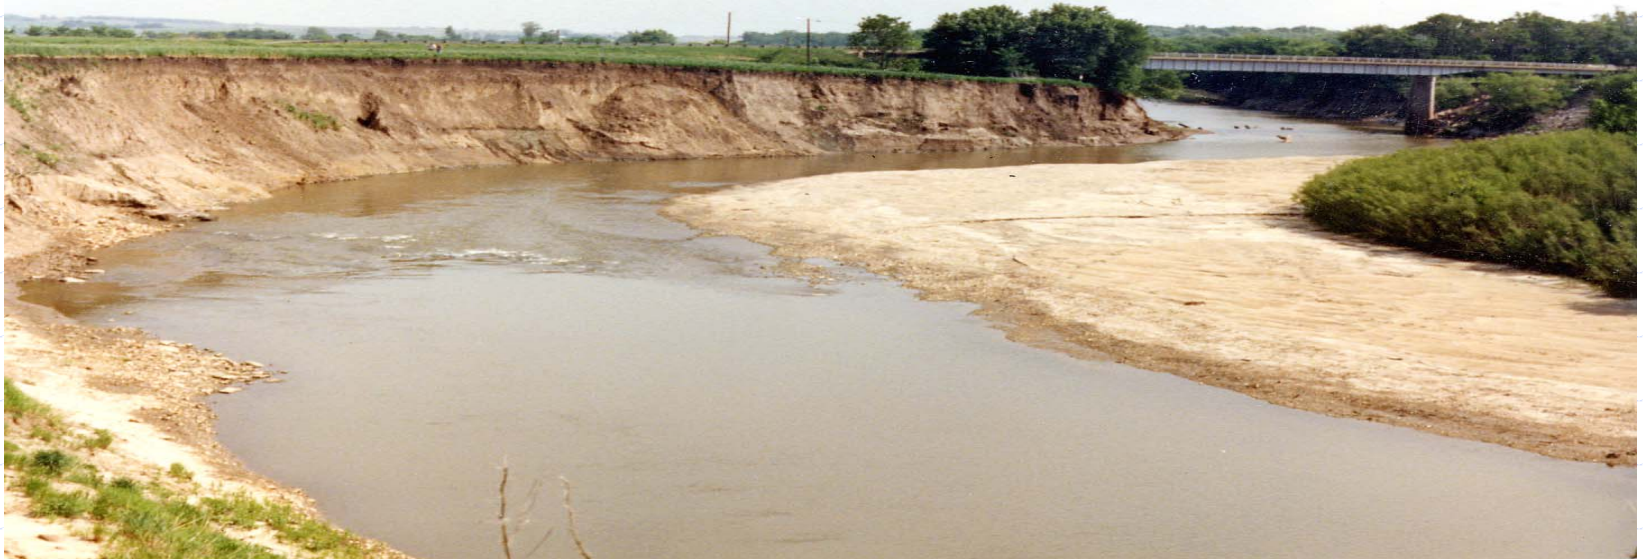
Example of a bridge failure

- ◆ South Fork Big Nemaha
- ◆ Active meandering channel
- ◆ Flood of 1993

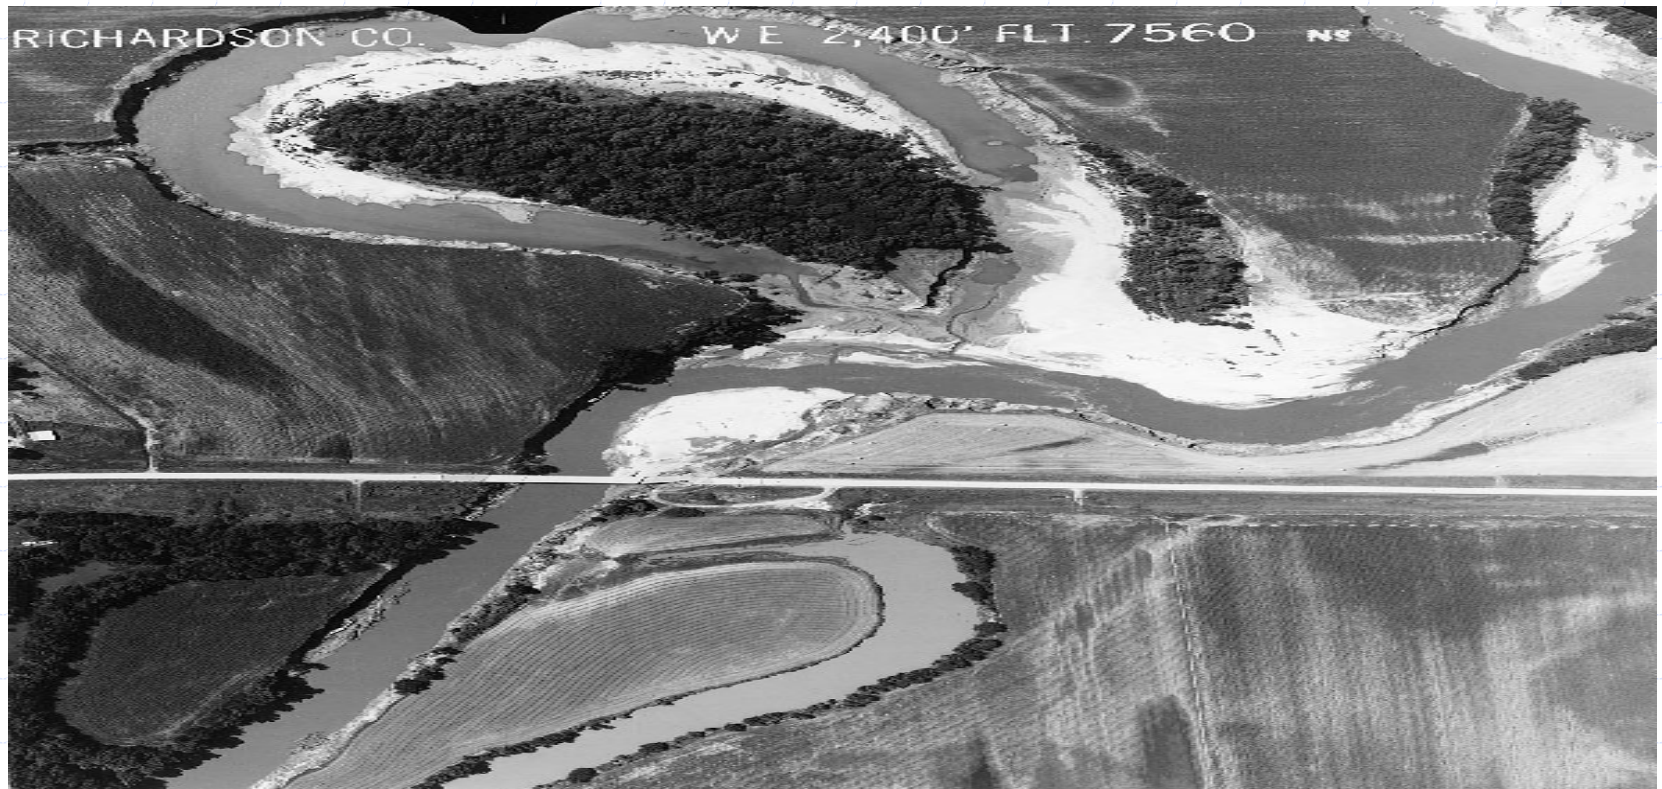
Arial view

◆ Meander cut-off

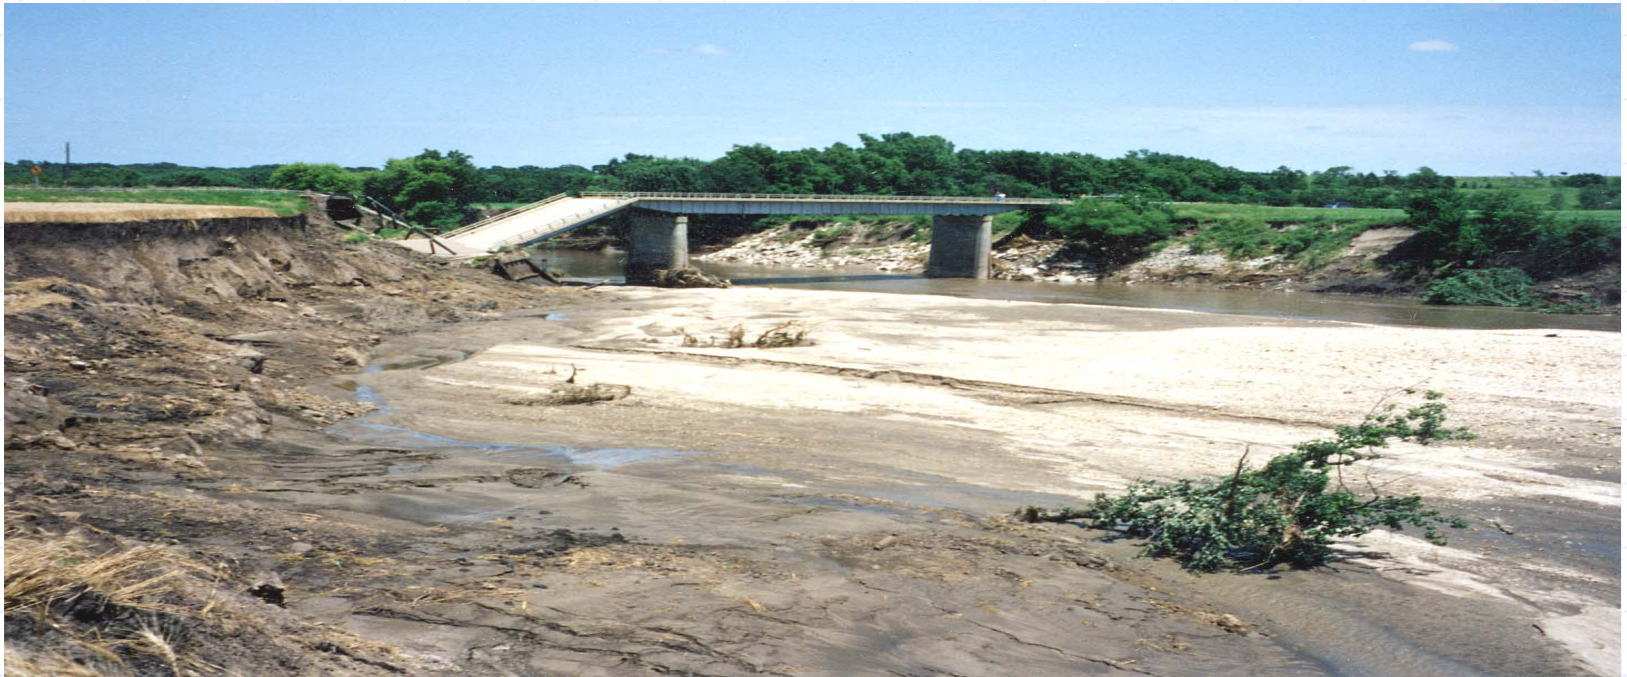
Bridge failure

- ◆ Tree debris on East abutment routed flow toward West abutment, washing it out.

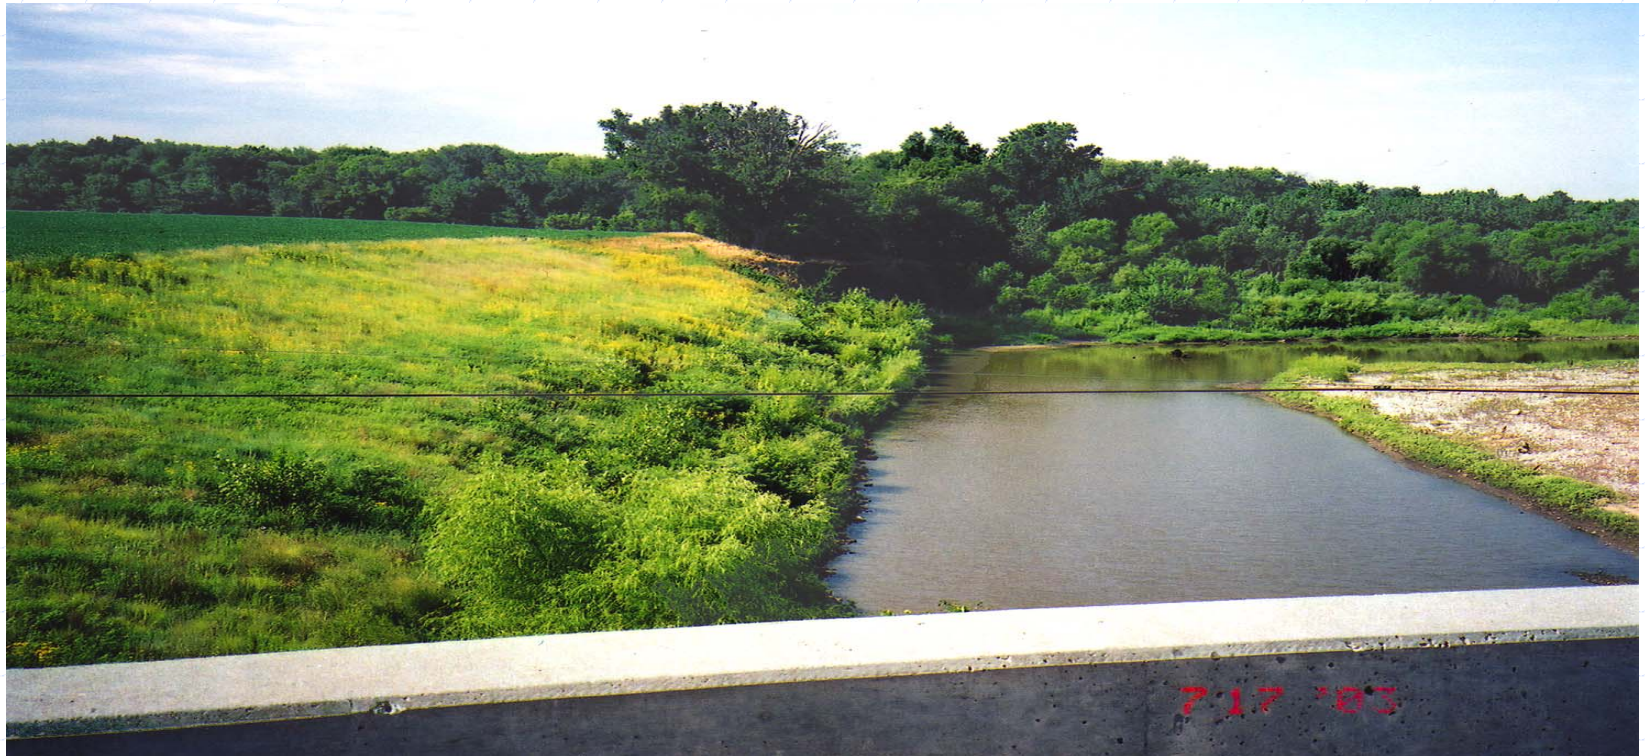
Stabilized channel

- ◆ Vegetation has filled in on both slopes
- ◆ Stable banks

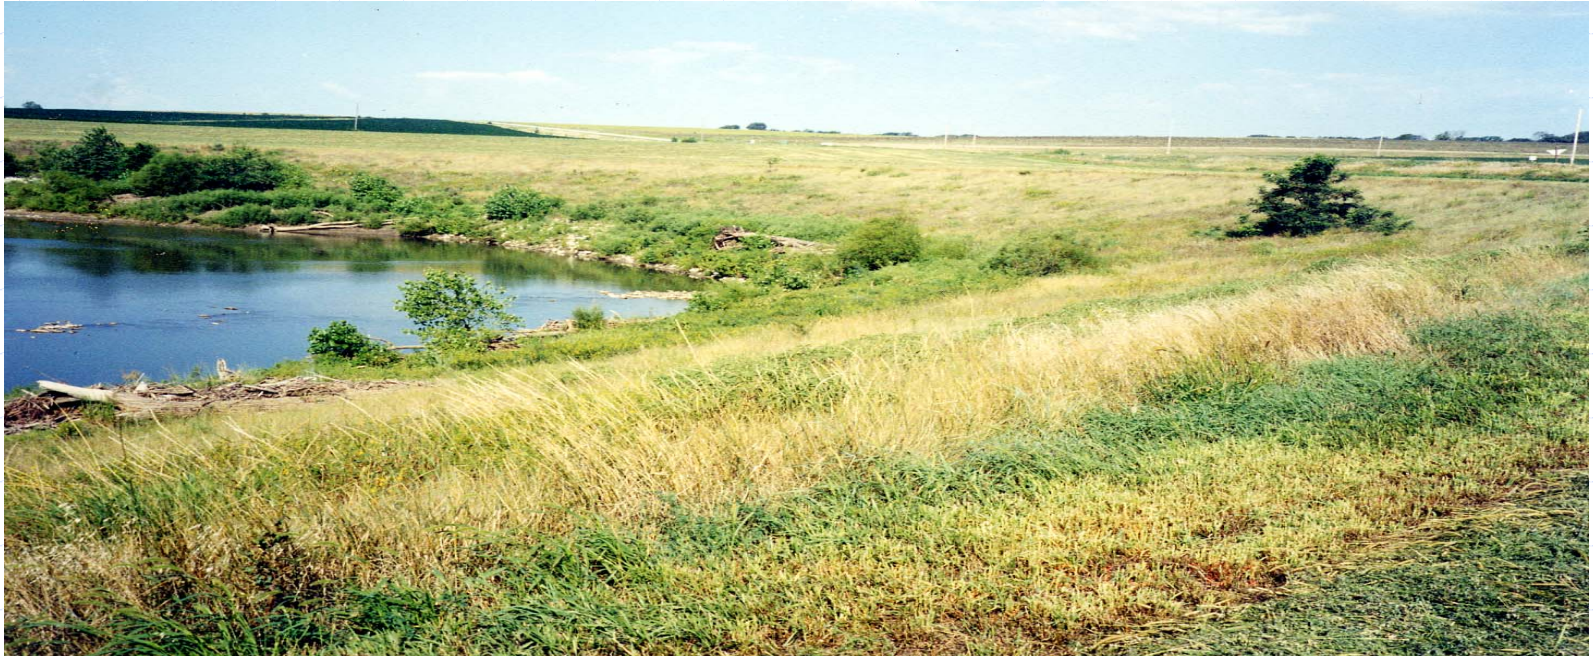
Stabilization channel

- ◆ Vegetation has filled in
- ◆ Stable banks
